# Visual Property Inspection Report

**11 / 19 Shortland Ave,  
Lurnea NSW 2171**

**March 7, 2024**

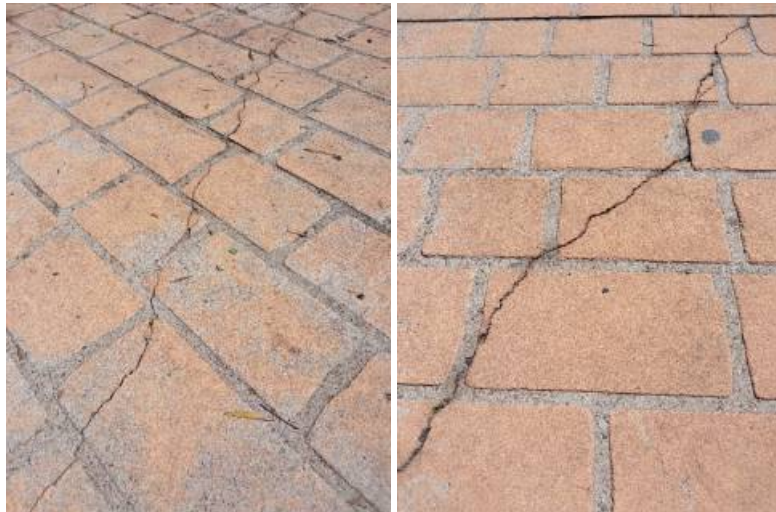
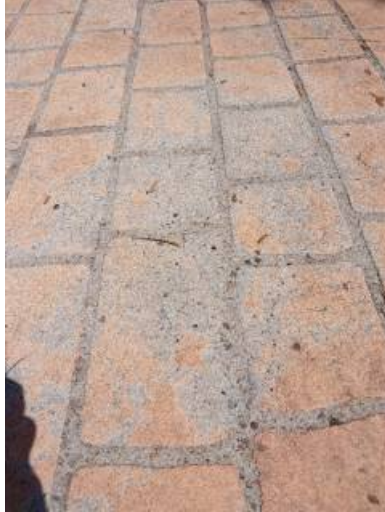
The concrete driveway has some visible cracking that should be monitored for further movement.

The driveway area has not been sealed to prevent deterioration.

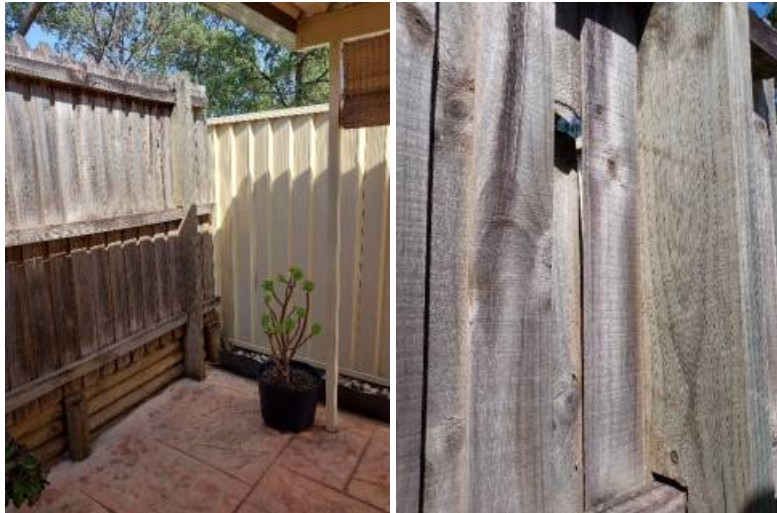
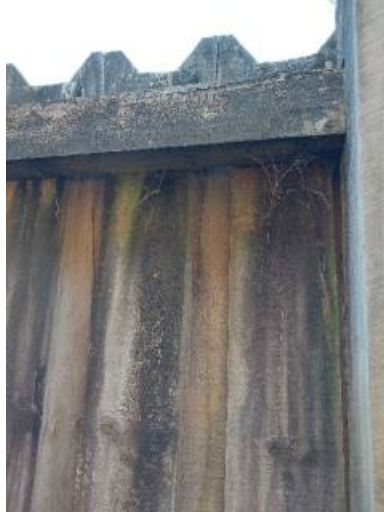
Southwestern side.

Minor damage to the fencing timber required repairing.

Wet rot decay and defects were noted to the wooden fencing. Repairs and or replacement of damaged timber will be required.

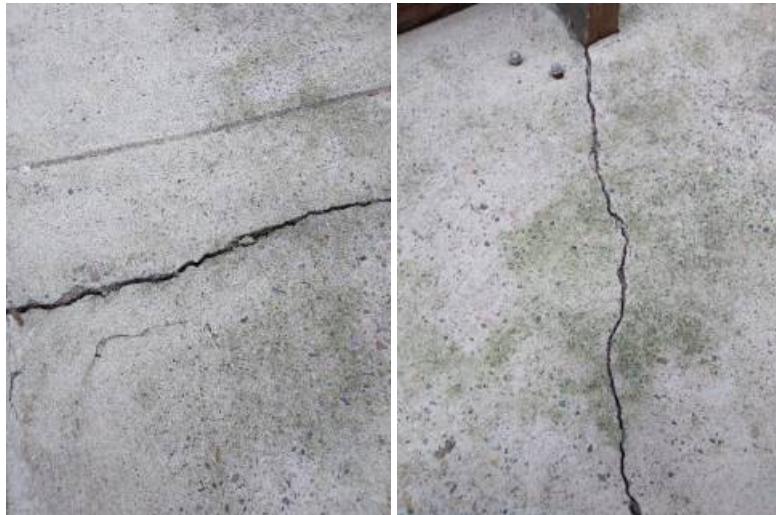
The paved paths/paved areas have subsided in areas and will require repair and or relaying.

The paths/paved areas have some visible cracking and damaged areas may require repair and or replacement.

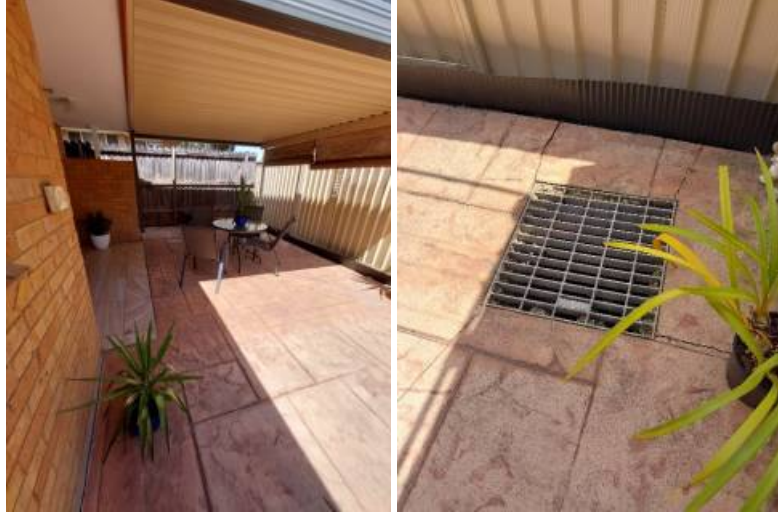
The surface water drainage to the external areas of the building in general appears to be inadequate. Drains should be installed to divert seepage and surface runoff water away from the building to prevent possible structural damage. The drains should be connected to a stormwater drainage system.

A drainage easement appears to be present on the allotment. Recommend council records be investigated to determine conditions and or restrictions in relation to this easement.

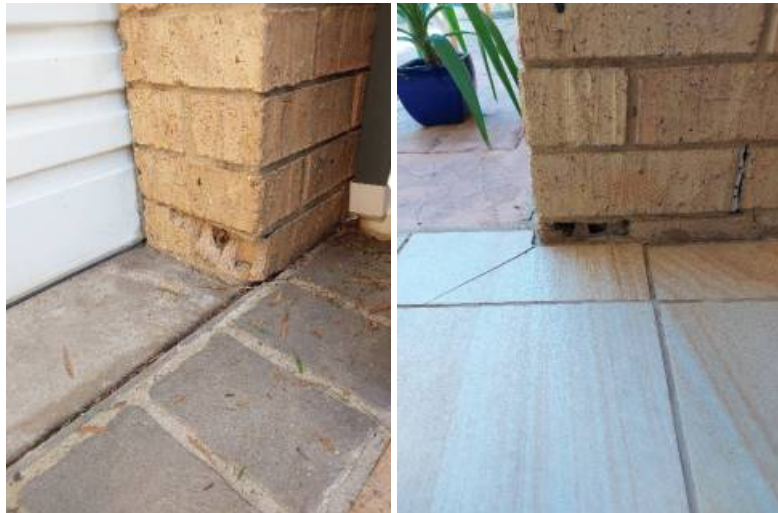
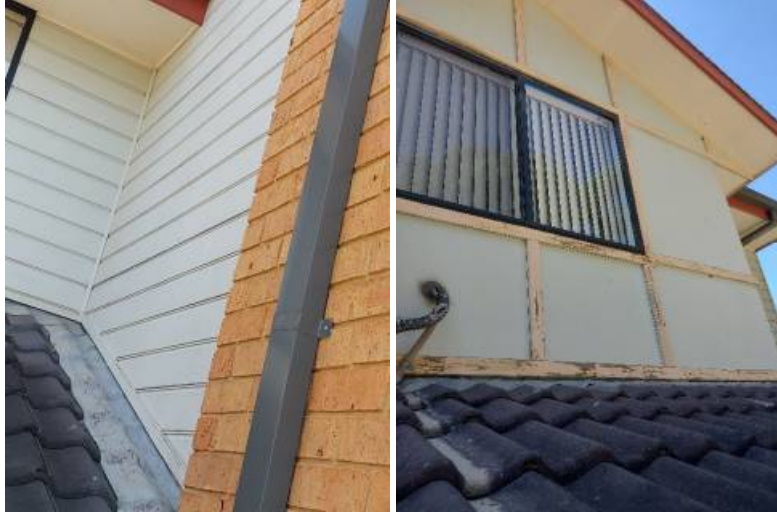
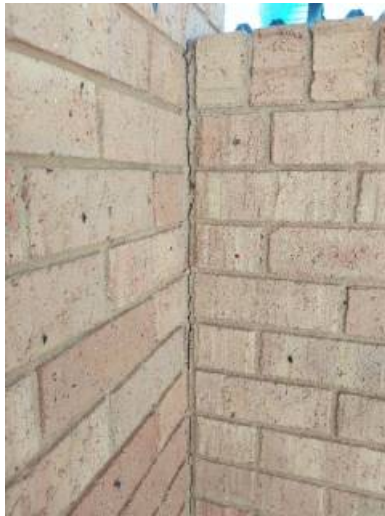
Front elevation. Rear elevation.

Brickwork is damaged and will require repairs and or replacement.

Cladding off and will require repairs and maintenance.

Paint deterioration was present to external surfaces. Maintenance and or repairs will be required. External wall sheeting is cracked and should be repaired to prevent water entry. Repairs and maintenance will be required.

Cracks are evident to masonry. Visible cracking appears minor. Periodic maintenance may be required. Please refer to section of this report - CRACKING OF BUILDING ELEMENTS for additional details.

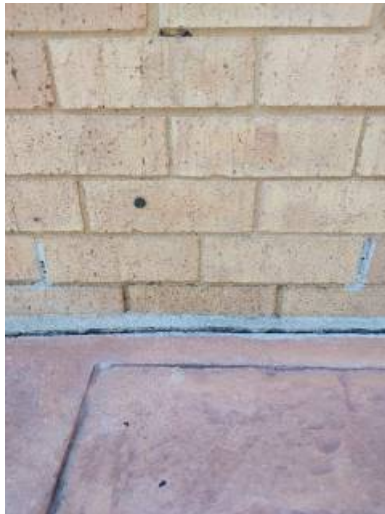
Weep holes to the base of the brick walls are blocked or partly blocked by gardens, soil or pathway heights and should be cleared to help prevent moisture and pest problems.

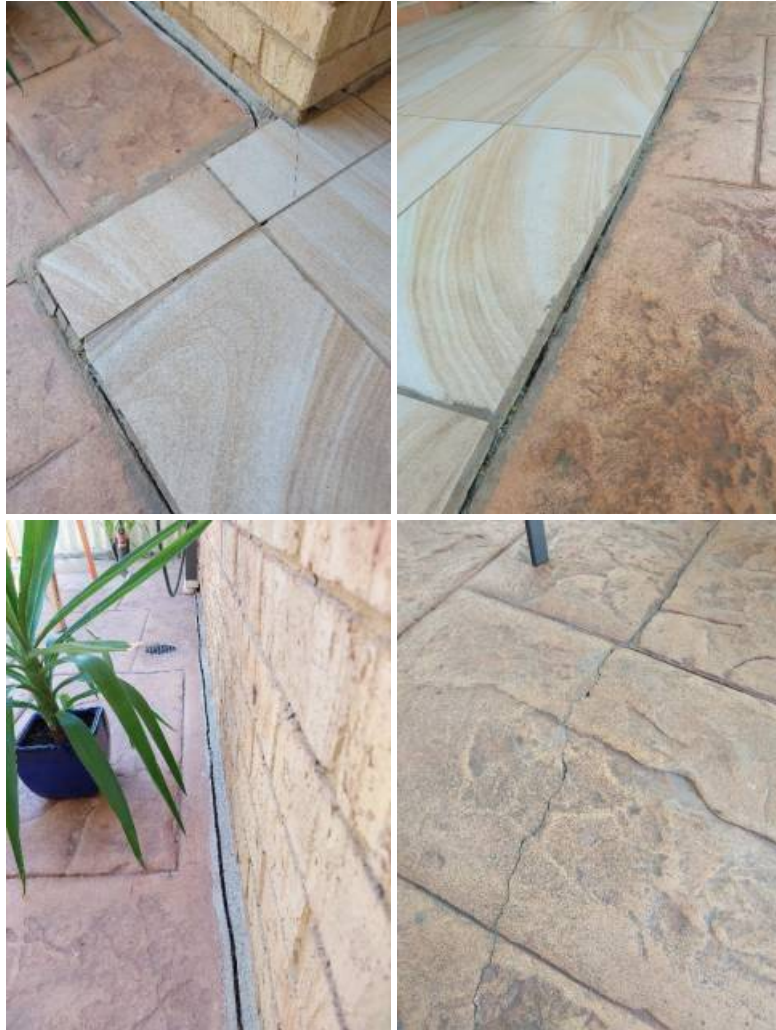
The drummy, loose floor tiles require repair. Cracked floor tiles are present and require replacement.

Cracking is present to the concrete floor. Cracking may allow water to enter the concrete, damage the steel reinforcement and cause concrete spalling. Damaged areas

should be repaired. Please refer to section of this report - CRACKING OF BUILDING ELEMENTS for additional details.

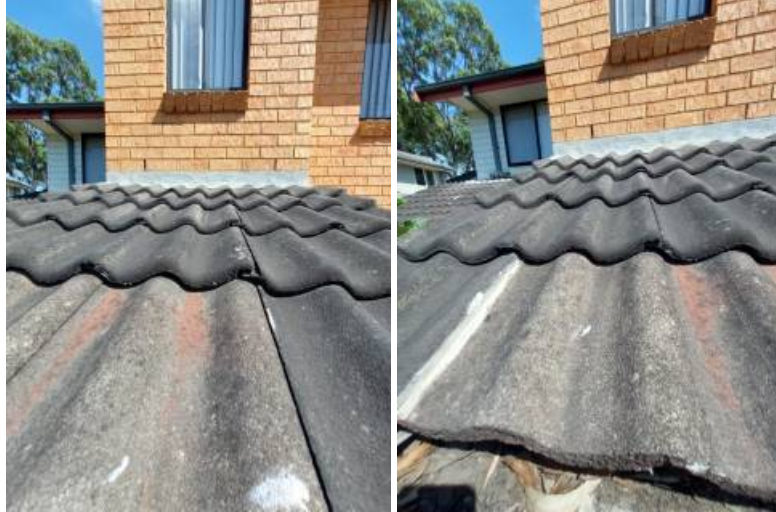
Minor fretting was noted to terracotta tiles. This will deteriorate gradually over time and replacement should be considered within 5 to 10 years. Please note: The replacement period is an estimate only. In some circumstances, fretting may be accelerated by various conditions and deterioration may occur in a shorter period of time than our estimate.

The number of roof tiles not seated properly and will require reseating and cement pointing. Driving rain will enter the roof void resulting in damaged ceilings , maintenance required.

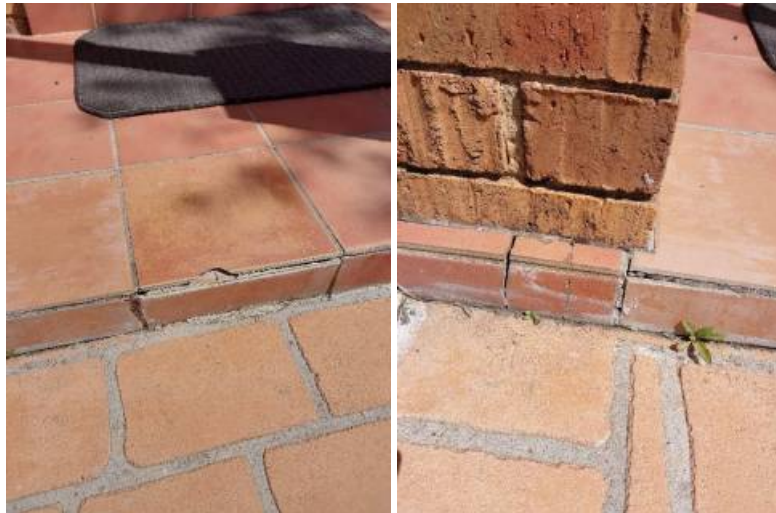
*Defects Or Maintenance Items:* The drummy, loose floor tiles require repair. Cracked floor tiles are present and require replacement.

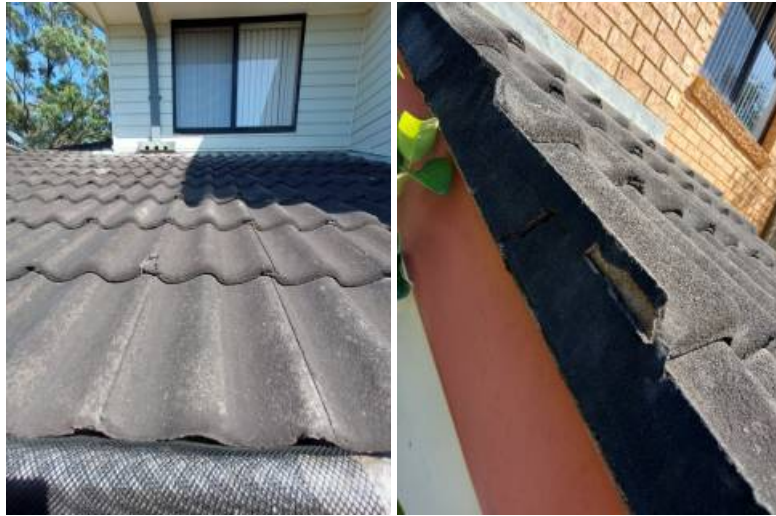
Roof area should be cleaned to remove, lichen and or moss buildup. Some repair & maintenance of the roofing material may be required following clean. A roofing expert

Mortar beds to the hip and ridge capping are cracked and require maintenance or re bedding and pointing in areas.

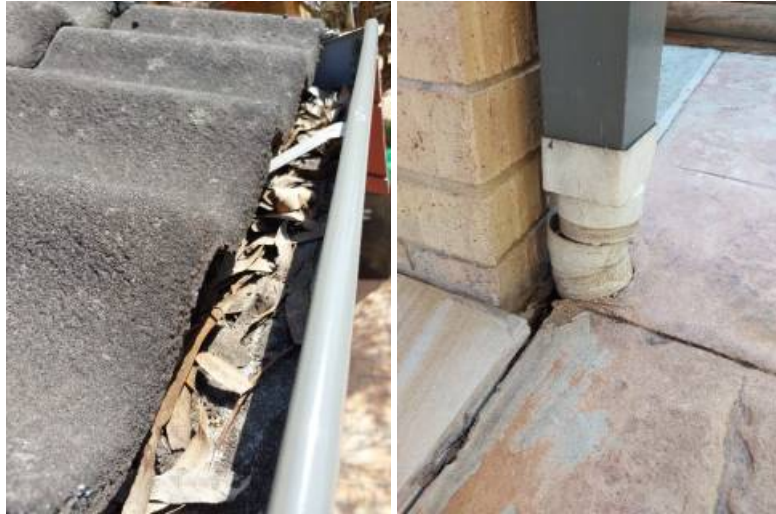
Downpipes are damaged or rusting and should be repaired or replaced as necessary.

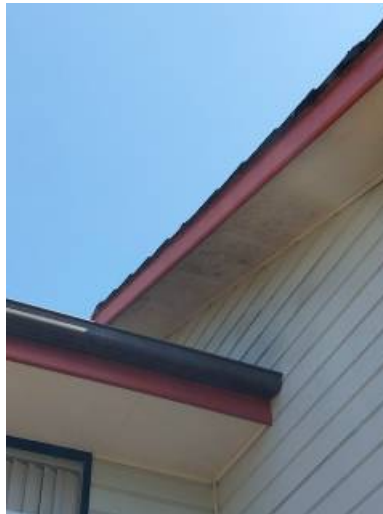
The eaves appear to be lined with fibre cement sheeting. Moderate wet rot decay is present to some sections of the timber eaves lining boards and damaged timber requires repair or replacement.

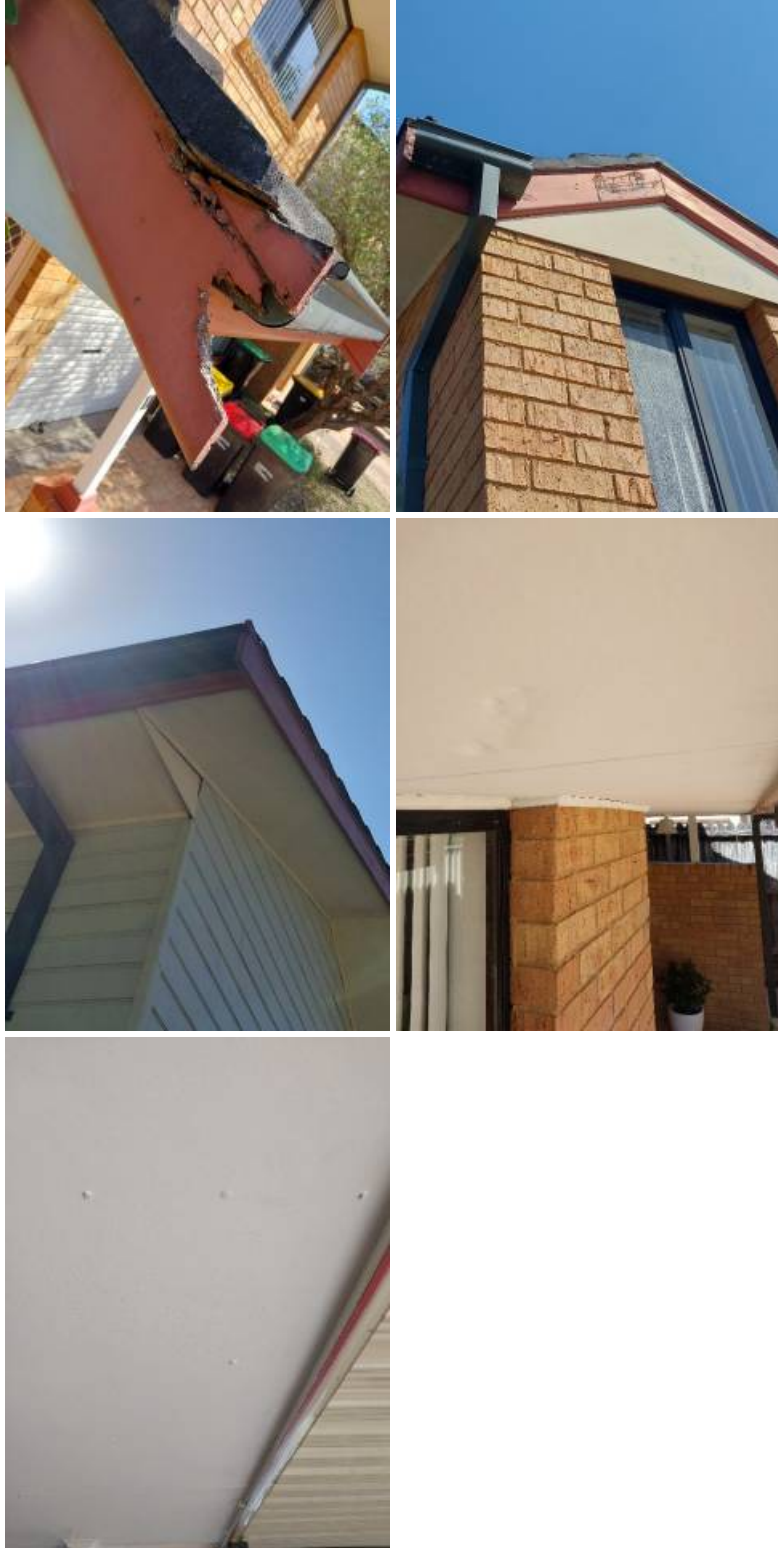
Moderate wet rot decay is present to some sections of the timber fascias/bargeboards. Maintenance and or replacement of damaged timber will be required.

Some fascias/bargeboards are loose and require re fixing.

Minor repairs/maintenance required prior to next repainting.

Nails are popping and are visible. This is generally due to movement in the timber framing. Periodic maintenance may be required.

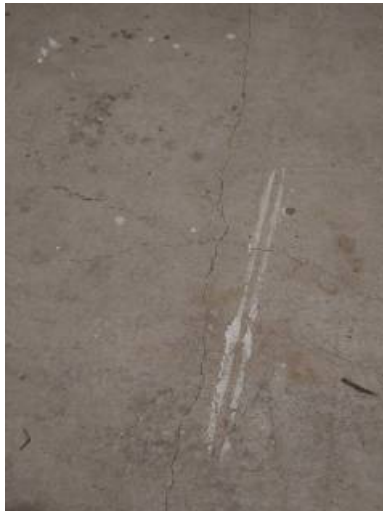
The concrete floor shows signs of minor cracking. Please refer to section of this report - **CRACKING OF BUILDING ELEMENTS** for additional details.

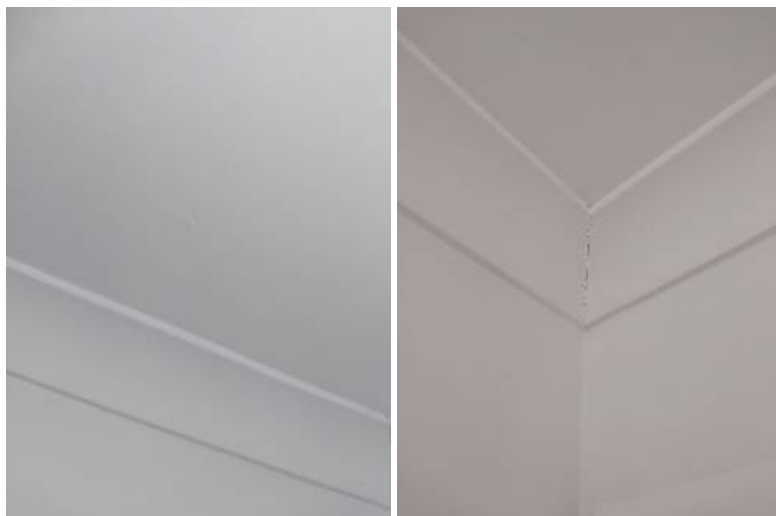
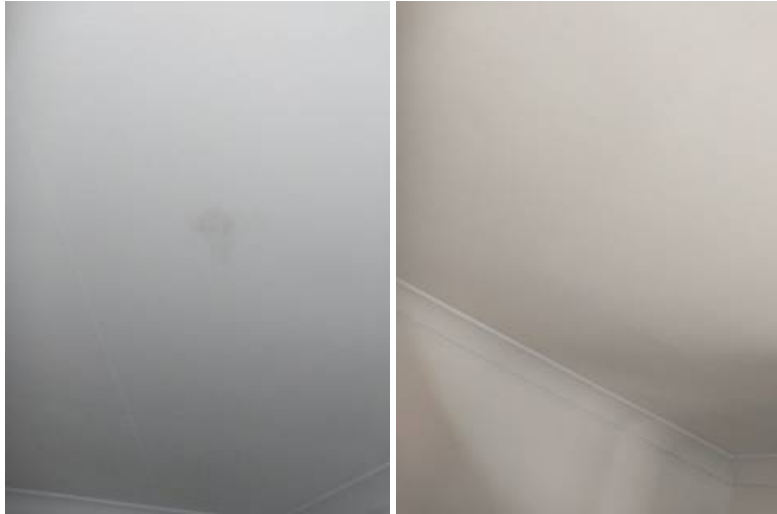
Main bedroom. Dining room. Stairs.

Minor settlement cracks were noted and these are typical of this type of material. Periodic maintenance may be required.

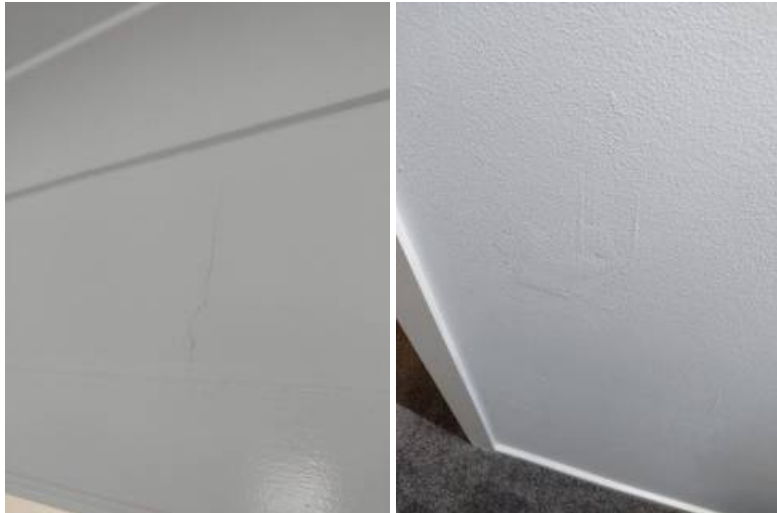
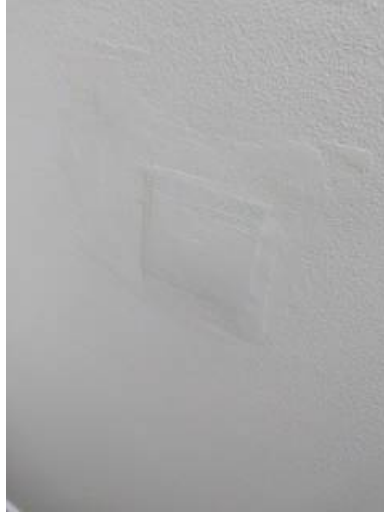
Main bedroom. Bedroom two.

Settlement cracks are evident to wall areas. Maintenance and repairs are required prior to next repainting.

Poor finishing was noted to some walls, required rectification.

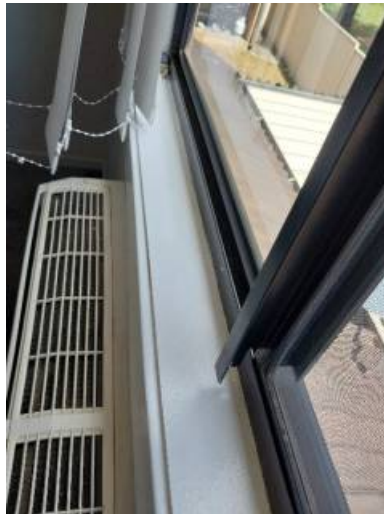
Main bedroom. Bedroom two. Stairs.

Windows to this area do not comply with strata laws requiring all windows to be secured to prevent a child from falling. Openings are not to be greater than 125mm. This can be achieved by locks limiting the opening of the window or the installation of security screens or grills.

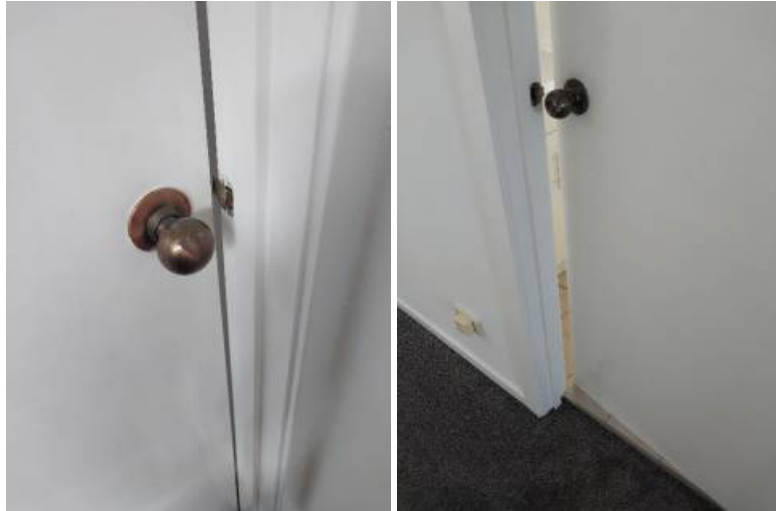
Bathroom two.

The door handle and latch requires adjusting and or repair. Rectification will be required.

Bathroom door jammed, Rectification will be required.

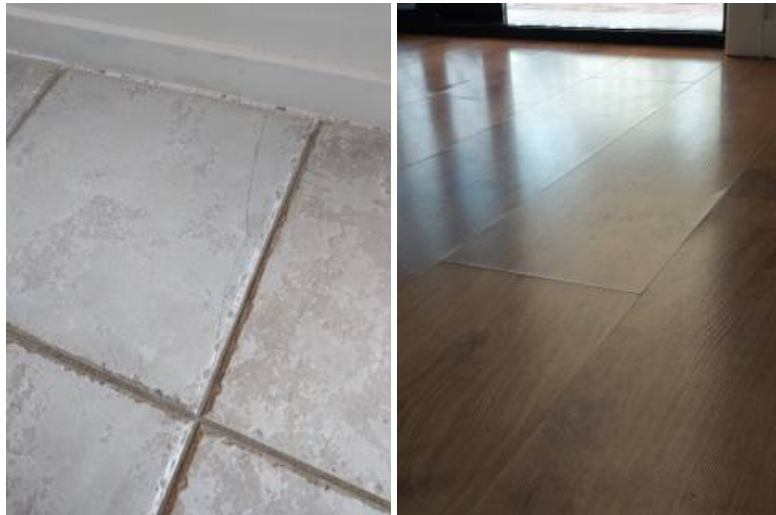
Cracking is evident to some floor tiles and damaged tiles should be considered for replacement.

Timber flooring finish is showing wear and tear and recommend poor areas be refinished. Minor damage noted requiring surface repair.

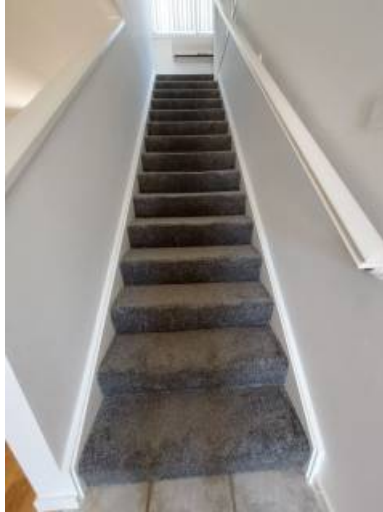
The stairs are constructed primarily from timber. The stair treads squeak and require maintenance.

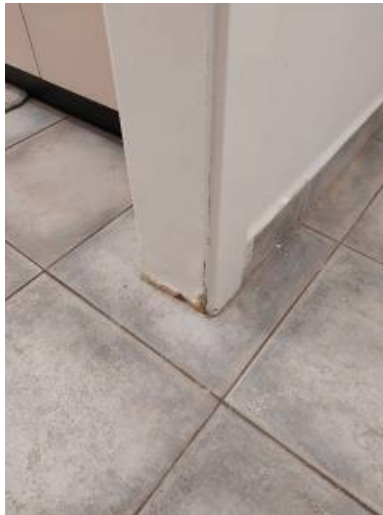
Bathroom. Kitchen.

Wet rot decay damage was noted to the following timbers and damaged areas will require maintenance, repair or replacement; Door frame. Architraves.

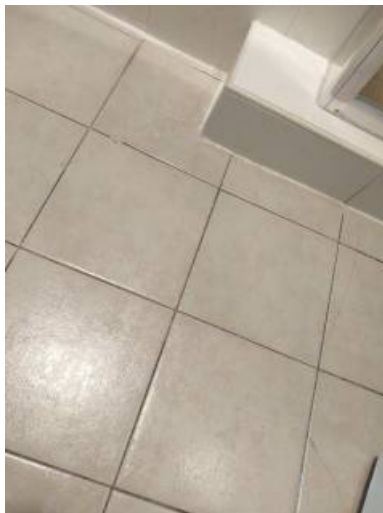
Some cracked tiles were noted in this area. Consider repair or replacement of damaged tiles.

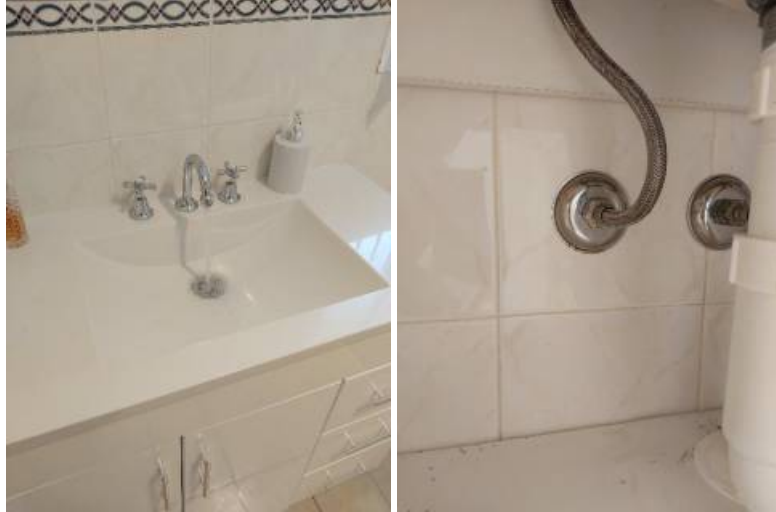
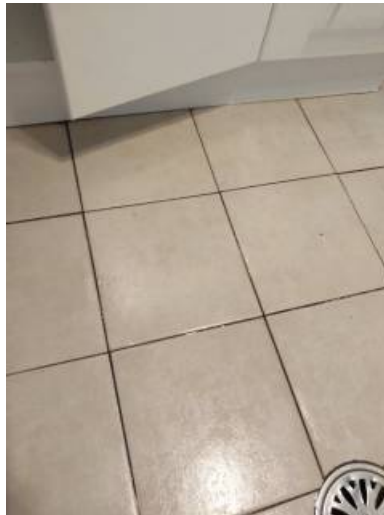
The basin & taps appear serviceable. The area below the basin appears to be leaking and this area should be further evaluated by a licensed plumber.

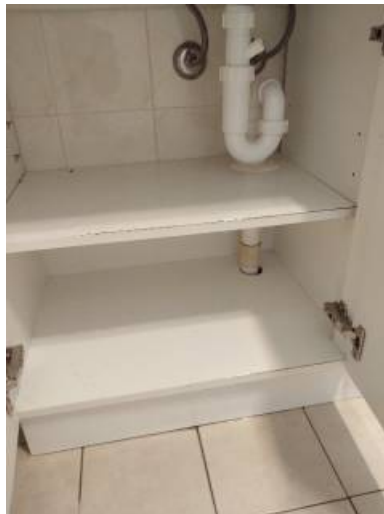
Water damage is noted to vanity cabinet and repair or replacement of affected areas is required.

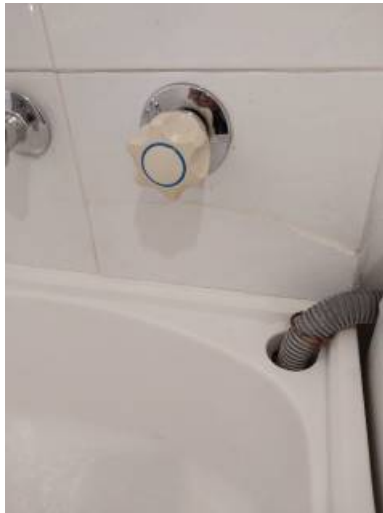
Some cracked tiles were noted in this area. Consider repair or replacement of damaged tiles.

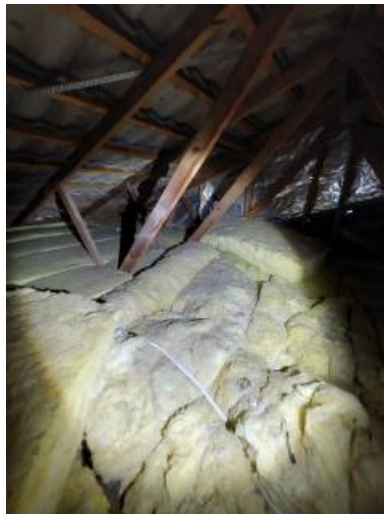
Insulation is covering lights and electrical fittings in the roof void. This may cause overheating and possibly a fire. Consult a licensed electrician to check on these installations and take necessary action to rectify.

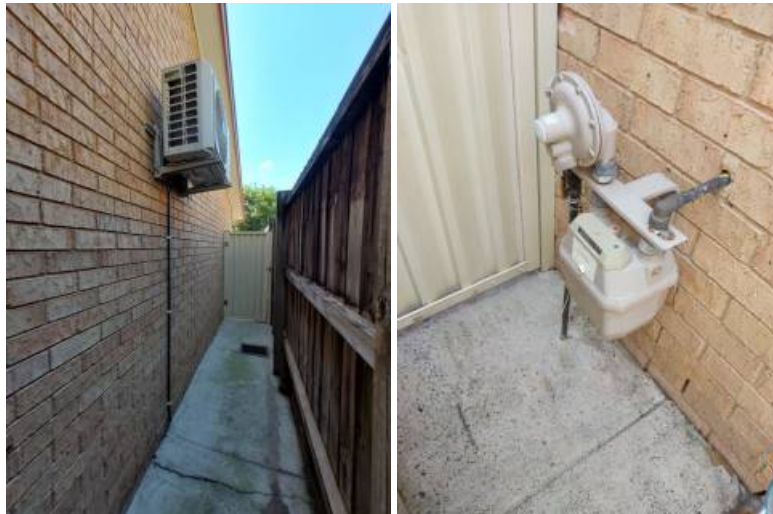
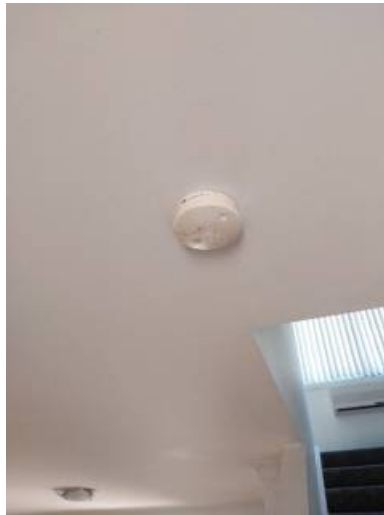
Air-conditioning unit is not installed on a level base and requires stabilising. Air-conditioning condensation discharge pipe should be diverted away from the external walls. Damp soil around the building may cause swelling and lead to heaving of structure and cracking to walls. Moisture also encourages termites into the area. We strongly recommend this pipe be connected to a drainage point.

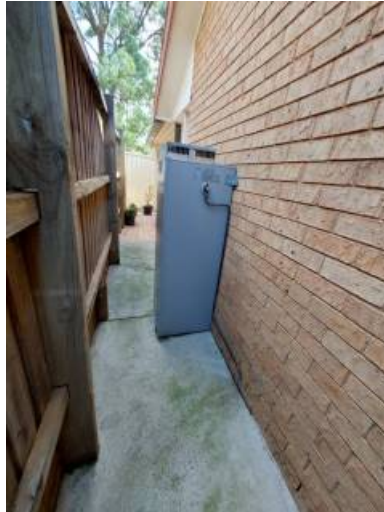
*Hot Water Service Type/Condition:* Gas hot water system: Hot water overflow pipe should be diverted away from the external walls. Damp soil around the building may cause swelling and lead to heaving of structure and cracking to walls. Moisture also encourages termites into the area. We strongly recommend the overflow relief valve be connected to a drainage point.

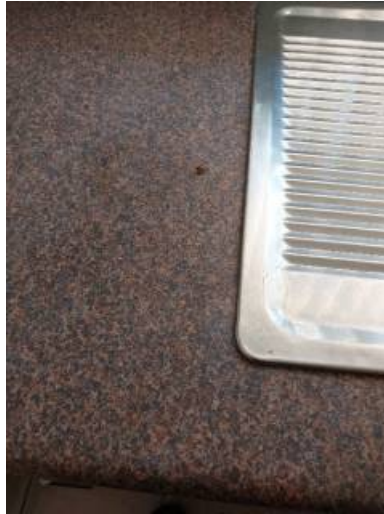
German cockroches activity found, needs treatment before moving in.

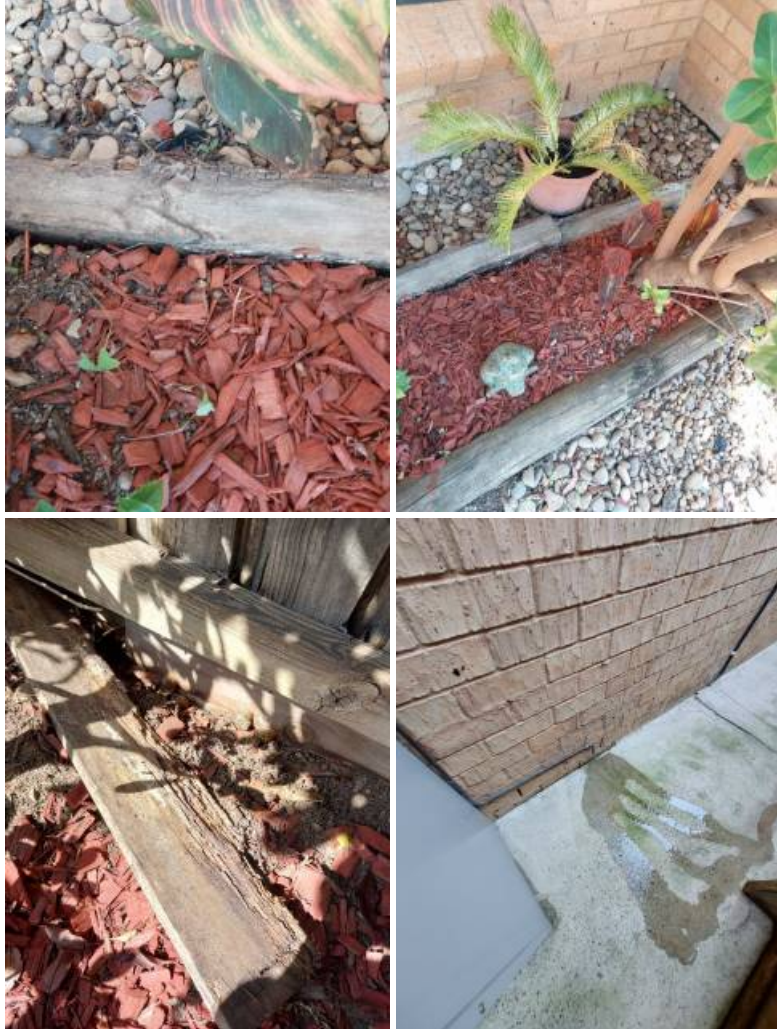
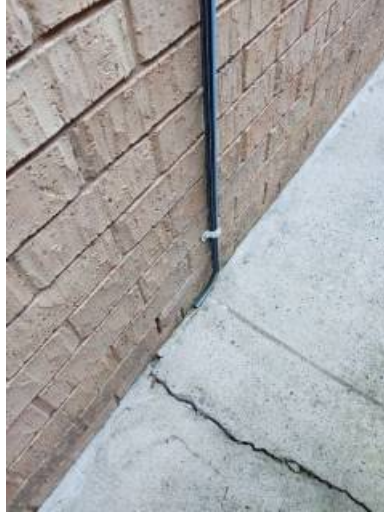
The air-conditioning condenser discharges adjacent to the external walls. We recommend modification so that water is discharged over a drain.
