# Visual Property Inspection Report

**11 / 19 Shortland Ave,  
Lurnea NSW 2171**

**March 7, 2024**

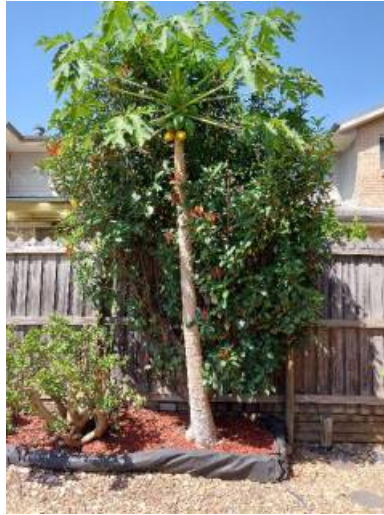
Inspection to the following fencing timbers was restricted in part by foliage -

Defects and or damage requiring rectification may not be apparent to the inspector due to restriction. If restrictions are noted we STRONGLY recommend access be gained to enable a full inspection of the area.

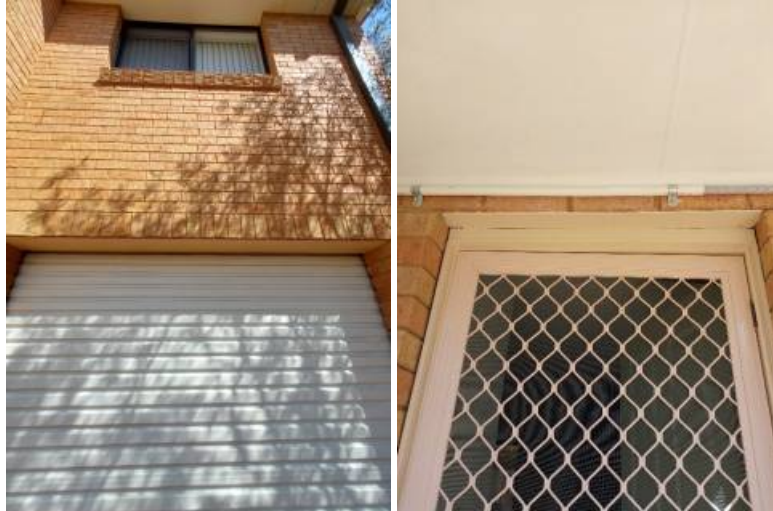
The condition of the lintels is generally acceptable.

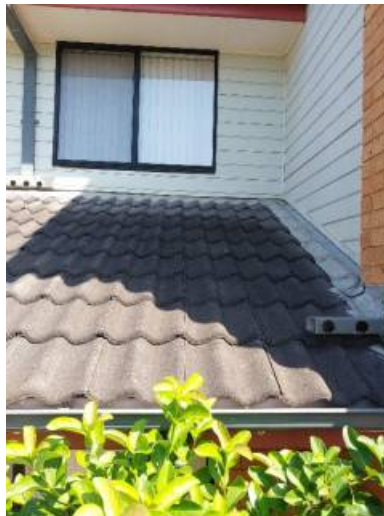
*Roof Flashing - Type And Condition:* Flashing material is of preformed aluminium. Flashings appear to be in serviceable condition.

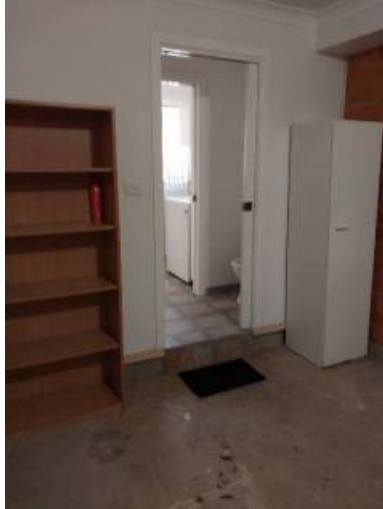
Inspection to sections of the exterior was restricted due to the stored goods. These goods must be removed to enable a more complete report to be submitted.

Defects and or damage requiring rectification may not be apparent to the inspector due to restriction. If restrictions are noted we **STRONGLY** recommend access be gained to enable a full inspection of the area.

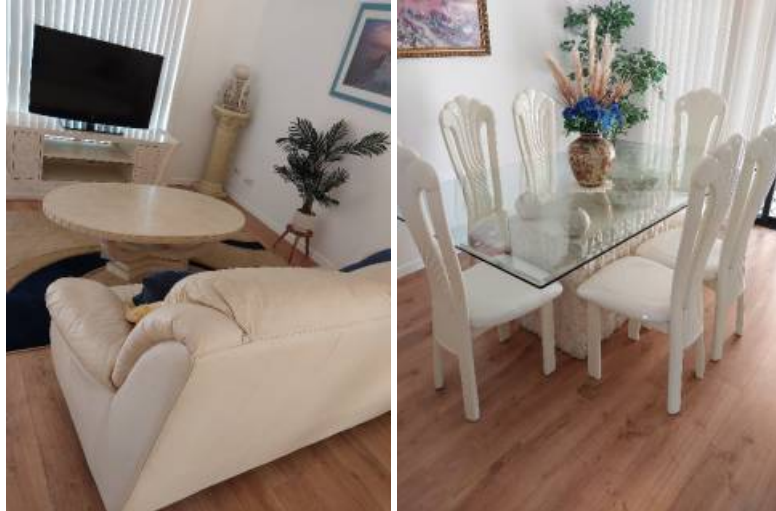
Both floorcoverings and furnishings were present and restricted inspection within this area.

Defects and or damage requiring rectification may not be apparent to the inspector due to restriction. If restrictions are noted we **STRONGLY** recommend access be gained to enable a full inspection of the area.

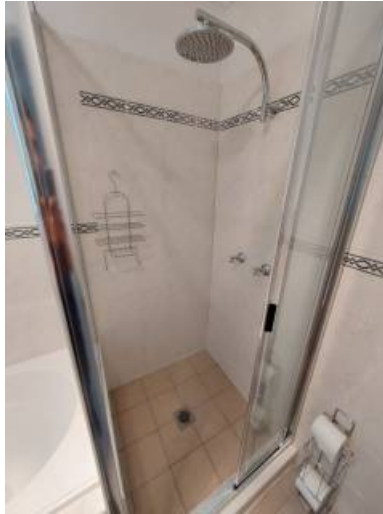
Some cracked tiles were noted in this area. Consider repair or replacement of damaged tiles.

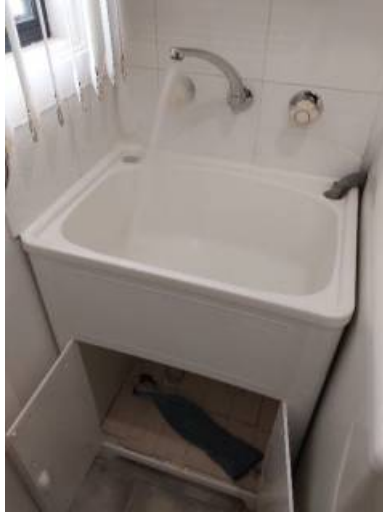
Some cracked tiles were noted in this area. Consider repair or replacement of damaged tiles.

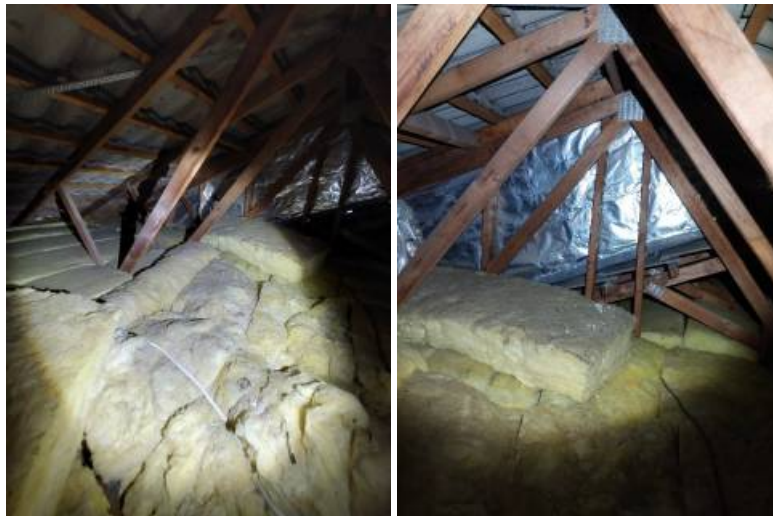
Insulation is present in the roof cavity. This restricted inspection to some roofing timbers. Removal of insulation is not within the scope of a standard visual inspection report.

Sarking membrane covered tile battens restricting inspection.

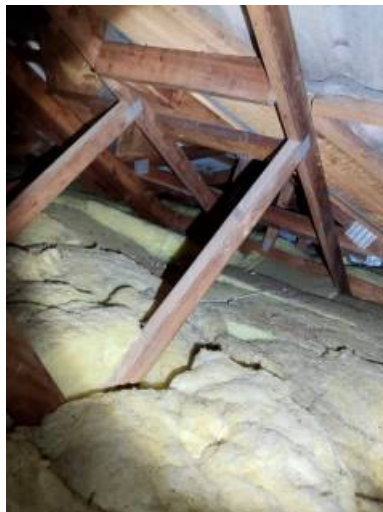
Inspection over the eaves and low areas to the perimeter of the building was restricted due to the low pitch and method of construction allowing only a limited visual inspection from a distance. Items such as top plates and ceiling and roof framing in these areas was not able to be fully inspected. The roof is of trussed style construction and due to the nature of this construction inspection within the roof cavity was limited in some areas.

A comment is not made where access was unable to be gained. Damage and or defects may be present and not detected in areas where inspection was limited, obstructed or access was not gained. If restrictions are noted we STRONGLY recommend access be gained to enable a full inspection inaccessible areas.

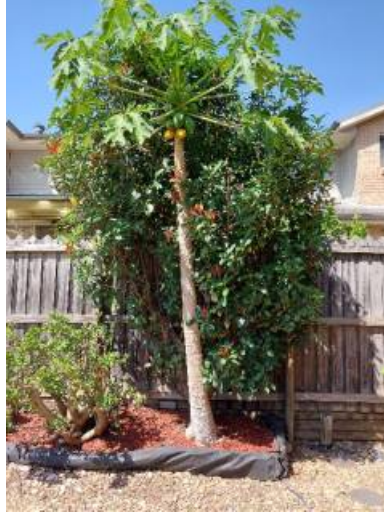
*Inspection Limitations* Inspection to the following fencing timbers was restricted in part by foliage -

Active termites or other timber damaging pests may be present and not detected in areas where inspection was limited, obstructed or access was not gained. See Section - Reasonable Access.

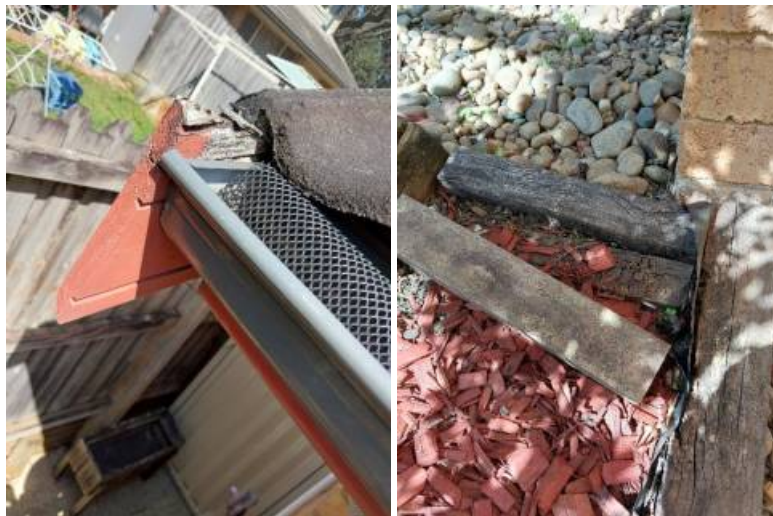
Sleepers or timber landscaping materials:

Visible timber damage appears minor to moderate. Please refer to the building report for details or if a building inspection was not commissioned we recommend a builder inspection and report on the property. Refer to the definitions section of this report - TERMS & LIMITATIONS - Timber Damage.

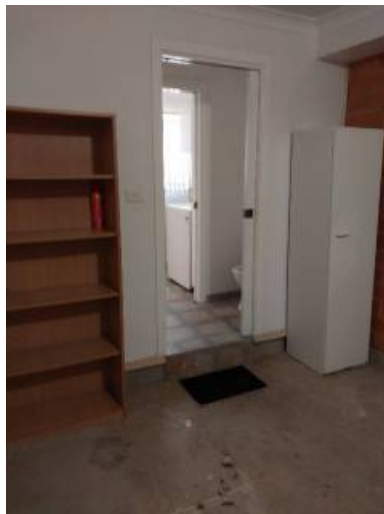
Inspection to sections of the exterior was restricted due to the stored goods. These goods must be removed to enable a more complete report to be submitted.

Active termites or other timber damaging pests may be present and not detected in areas where inspection was limited, obstructed or access was not gained. Recommend access be gained.

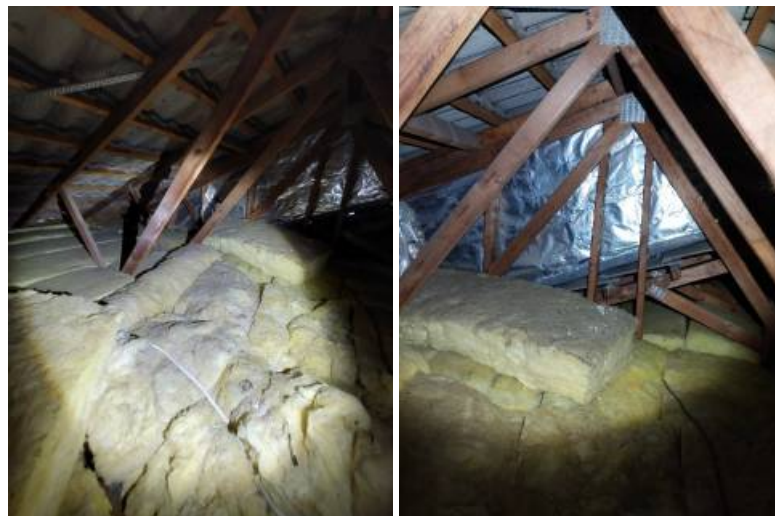
Insulation is present in the roof cavity. This restricted inspection to some roofing timbers. Removal of insulation is not within the scope of a standard visual inspection report.

Sarking membrane covered tile battens restricting inspection.

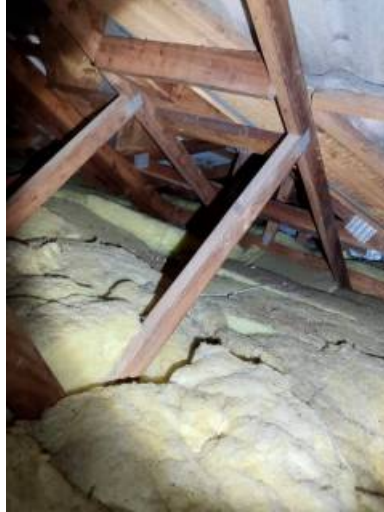
Inspection over the eaves and low areas to the perimeter of the building was restricted due to the low pitch and method of construction allowing only a limited visual inspection from a distance. Items such as top plates and ceiling and roof framing in these areas was not able to be fully inspected. The roof is of trussed style construction and due to the nature of this construction inspection within the roof cavity was limited in some areas.

A comment is not made where access was unable to be gained. Active termites, other timber damaging pests or timber damage may be present and not detected in areas where inspection was limited, obstructed or access was not gained. Timbers above the areas nominated were not accessed and not able to be inspected. Recommend access be gained to allow a full inspection of inaccessible areas.
